COPY NO. 6  
RM No. E8F01a

# RESEARCH MEMORANDUM

NATURAL ICING OF AN AXIAL-FLOW TURBOJET ENGINE  
IN FLIGHT FOR A SINGLE ICING CONDITION

By Loren W. Acker

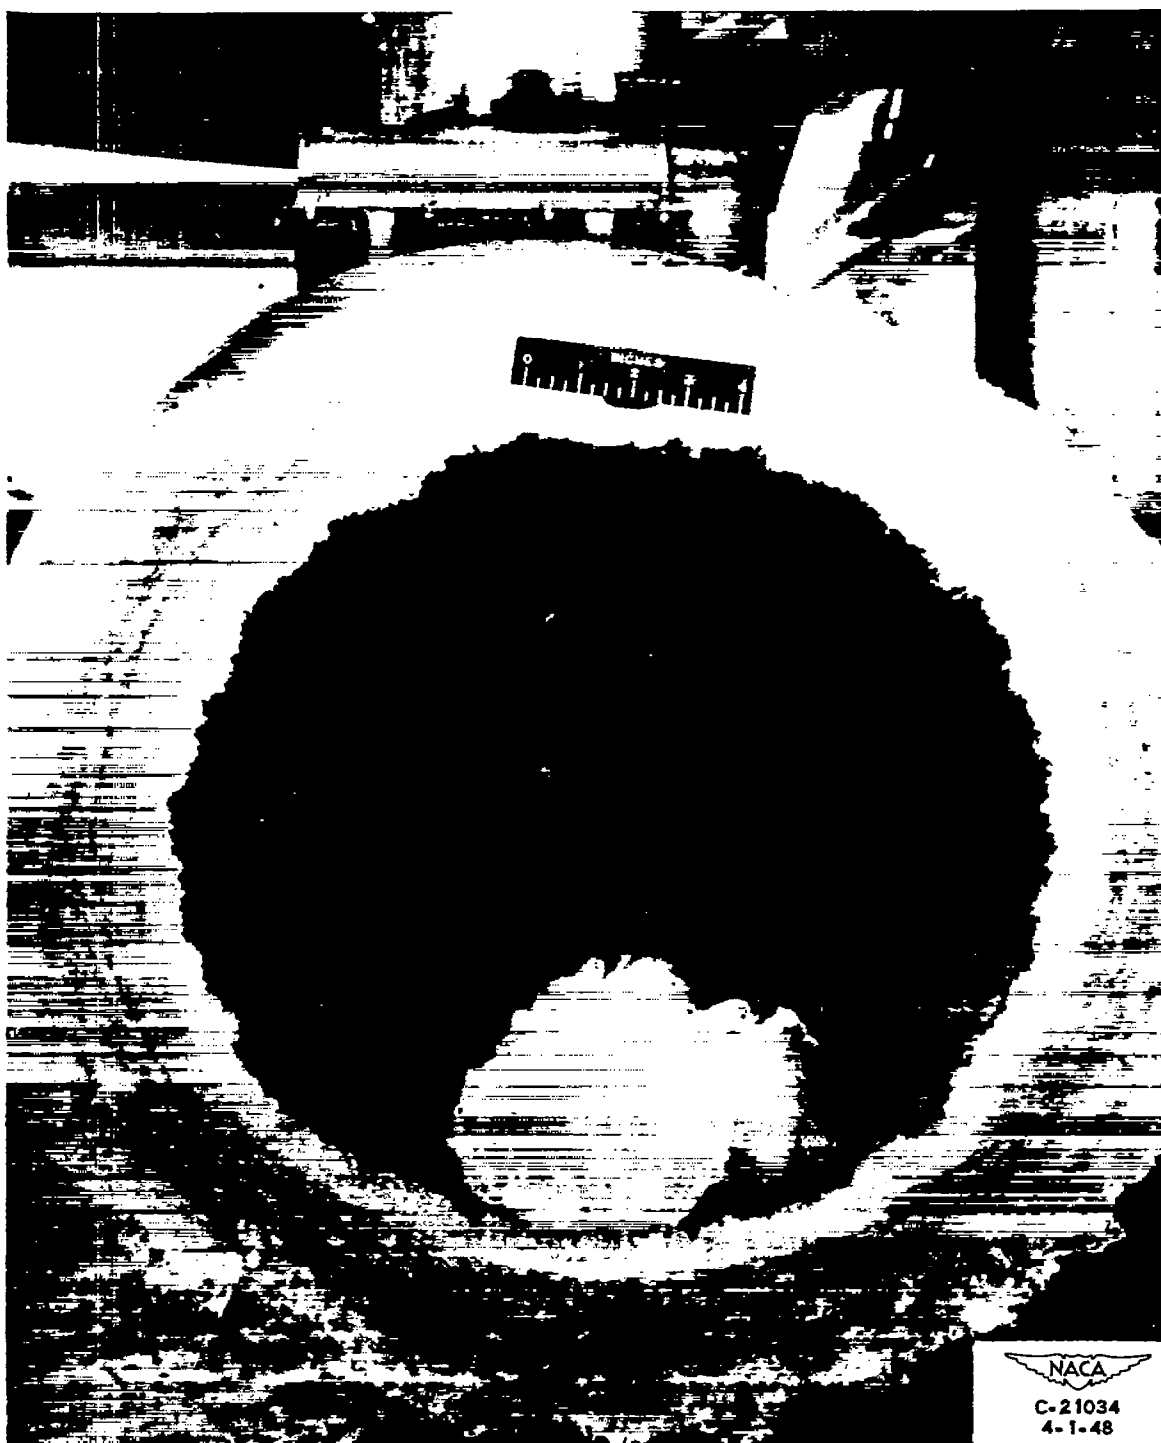
(b) Front view.

The ice formation obtained on the jet-engine cowl inlet is shown in figure 3. The degree of ice accumulation on the engine inlet is indicated by figures 4(a) and 4(b), which are side and front views, respectively, of the engine inlet photographed after landing. Very little ice, if any, collected on the engine-inlet guide vanes. The ice shown at the bottom of the inlet guide vanes is believed to consist of pieces broken from the ice formation on the starter housing or the support struts. A time history of the data taken in the icing condition is shown in figure 5. Engine jet thrust, fuel flow, and tail-pipe temperature are shown in figure 5(a), average droplet size, free-air temperature, and liquid-water content are shown in figure 5(b). Engine and icing data were taken upon entering the icing cloud and periodically during the encounter with the icing condition, which lasted for approximately 1 hour. The engine speed was maintained at 11,000 rpm. A sudden drop in engine thrust as the airplane entered the icing cloud is believed to be a result of ice collection on the cowl lip, which disrupted the air flow and destroyed the pressure recovery at the compressor inlet.

Figure 4. - Concluded. Ice formation on engine cowling after icing flight.

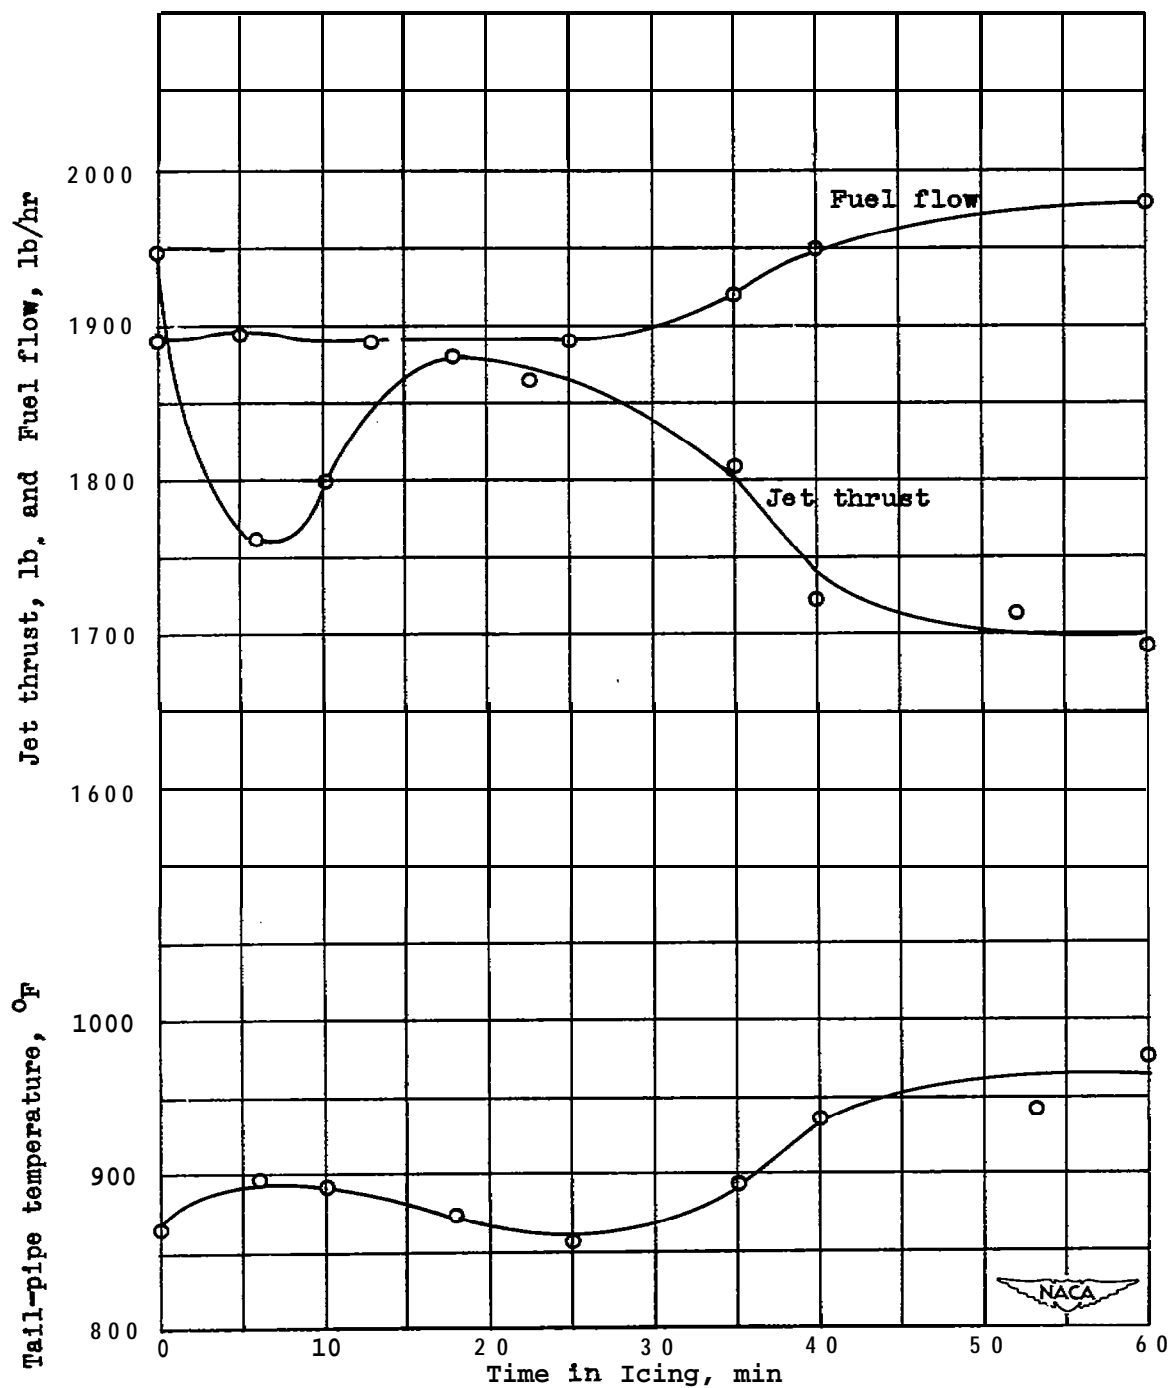
(a) Engine performance data.

At the end of 60 minutes, the thrust, the tail-pipe temperature, and the fuel flow had stabilized (fig. 5(a)). During the icing encounter, the thrust decreased from 1950 to 1700 pounds, the tail-pipe temperature increased from 865° to 965° F, and the fuel flow increased from 1890 to 1980 pounds per hour. During the time in the icing condition, the free-air temperature varied from 25° to 31° F, the average droplet size varied from 5.4 to 12.1 microns, and the liquid-water content varied from 0.077 to 0.490 gram per cubic meter (fig. 5(b)).

Figure 5. ~ Time history of data taken in icing condition.

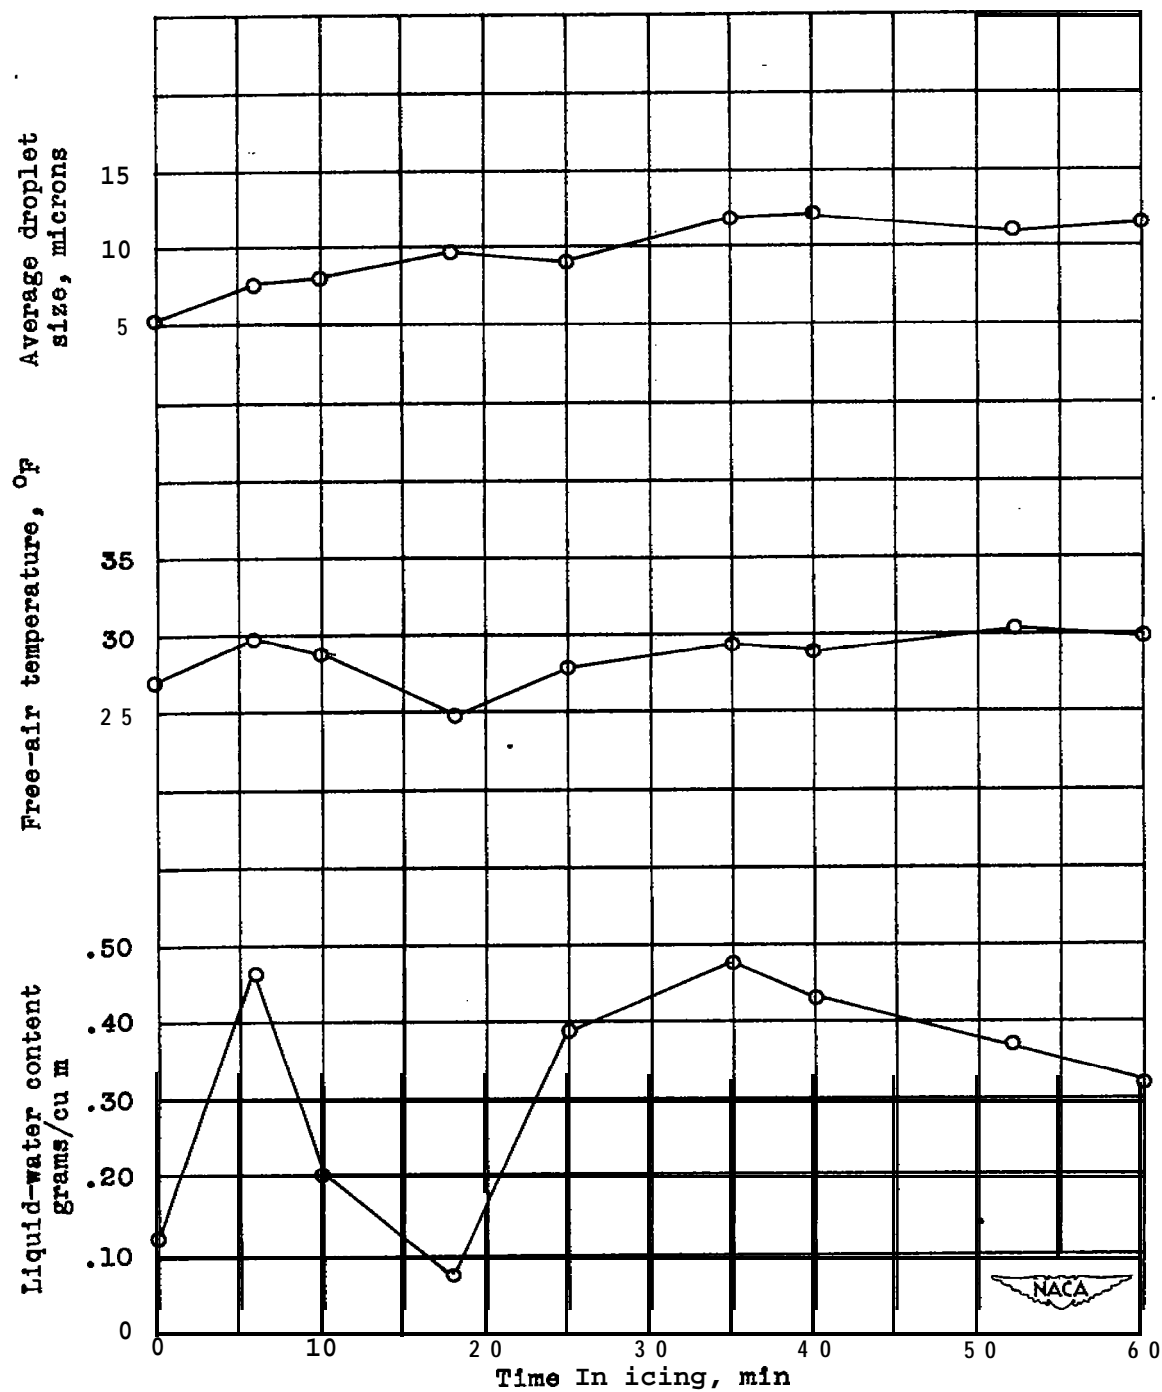
(b) Meteorological data.

After 18 minutes in the icing condition, the engine returned to nearly normal operation. Because of the very low liquid-water content at that time (0.077 gram per cubic meter) and high free-air temperature (25° F), the ice accumulation on the engine inlet melted and ran back along the cowl (fig. 5(b)).

After 35 minutes, the liquid-water *content* rapidly rose to 0.49 gram per cubic meter (fig. 5(b)). The fuel flow then increased to maintain the engine speed, which resulted in a corresponding increase in tail-pipe temperature. At this point the thrust rapidly decreased.

After 35 minutes, the liquid-water content gradually decreased from 0.49 to 0.32 gram per cubic meter at the end of the run (fig. 5(b)). The additional ice accumulation on the engine resulted in a gradual increase in fuel flow and tail-pipe temperature and a gradual decrease in jet thrust.

Figure 5 . - Concluded. Time history of data taken in icing condition.
